## FSP-951-IV Series Photoelectric Detectors Operating in CLIP Protocol

DATE: February 13, 2019

Document: SB19-02-01

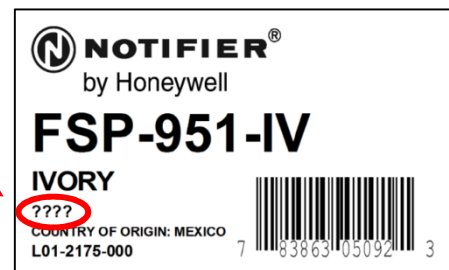
Example device carton label

4-digit date code
