HONEYWELL POWER PRODUCTS

TB21.1HP

***** Important Second Notice for HWF2-COM Series Installations *****
Prompt Action Required

HWF2A-COM / HWF2V-COM Potential Communication Issue
Over-the-Air Firmware Update Required

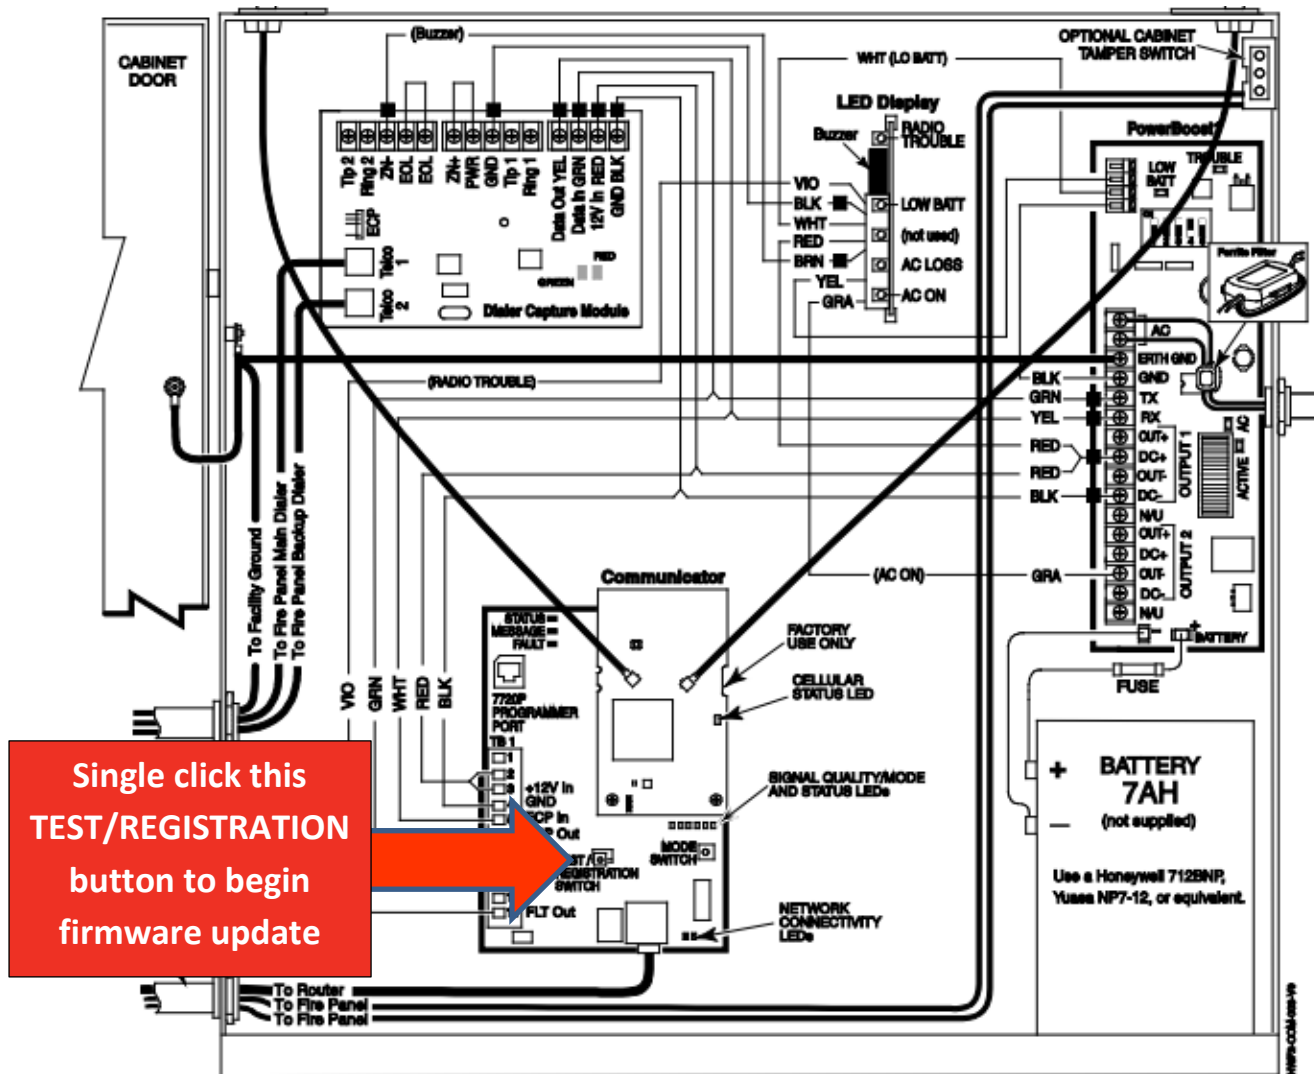
DIAGRAM A:

This process should take no longer than ten minutes. See Diagram A below for the location of the Test/Registration switch.

Firmware updates can be initiated on site by **clicking the Test/Registration switch one time** to generate a test message to AlarmNet, which will initiate the firmware update process. If your communicator already has the latest firmware, the test process will complete, and the firmware update process will not start.
